# Absolute Encoder Configuration

Endat2.2

BissC

## Application Note

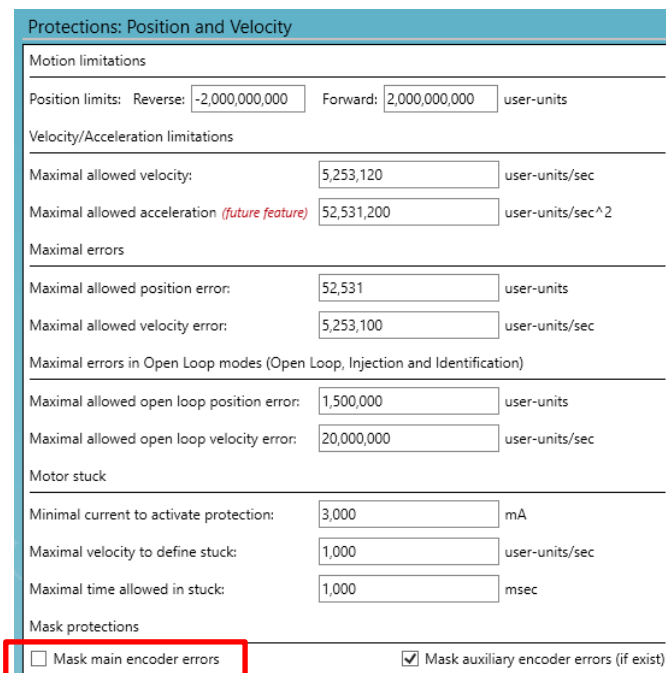
page. Ensure that the  Mask main encoder errors checkbox is not checked.

Protections: Position and Velocity	
Motion limitations	
Position limits: Reverse:	-2,000,000,000 user-units
Forward:	2,000,000,000 user-units
Velocity/Acceleration limitations	
Maximal allowed velocity:	5,253,120 user-units/sec
Maximal allowed acceleration (future feature)	52,531,200 user-units/sec^2
Maximal errors	
Maximal allowed position error:	52,531 user-units
Maximal allowed velocity error:	5,253,100 user-units/sec
Maximal errors in Open Loop modes (Open Loop, Injection and Identification)	
Maximal allowed open loop position error:	1,500,000 user-units
Maximal allowed open loop velocity error:	20,000,000 user-units/sec
Motor stuck	
Minimal current to activate protection:	3,000 mA
Maximal velocity to define stuck:	1,000 user-units/sec
Maximal time allowed in stuck:	1,000 msec
Mask protections	
<input type="checkbox"/> Mask main encoder errors	<input checked="" type="checkbox"/> Mask auxiliary encoder errors (if exist)

Figure 1. Screen capture of Protections: Position and Velocity Menu page.
